X-33 LH₂ Tank Failure Investigation Findings

Presented by
Mindy Niedermeyer
MSFC

Manufacturing Problem Prevention Workshop

Feb 26-27, 2002

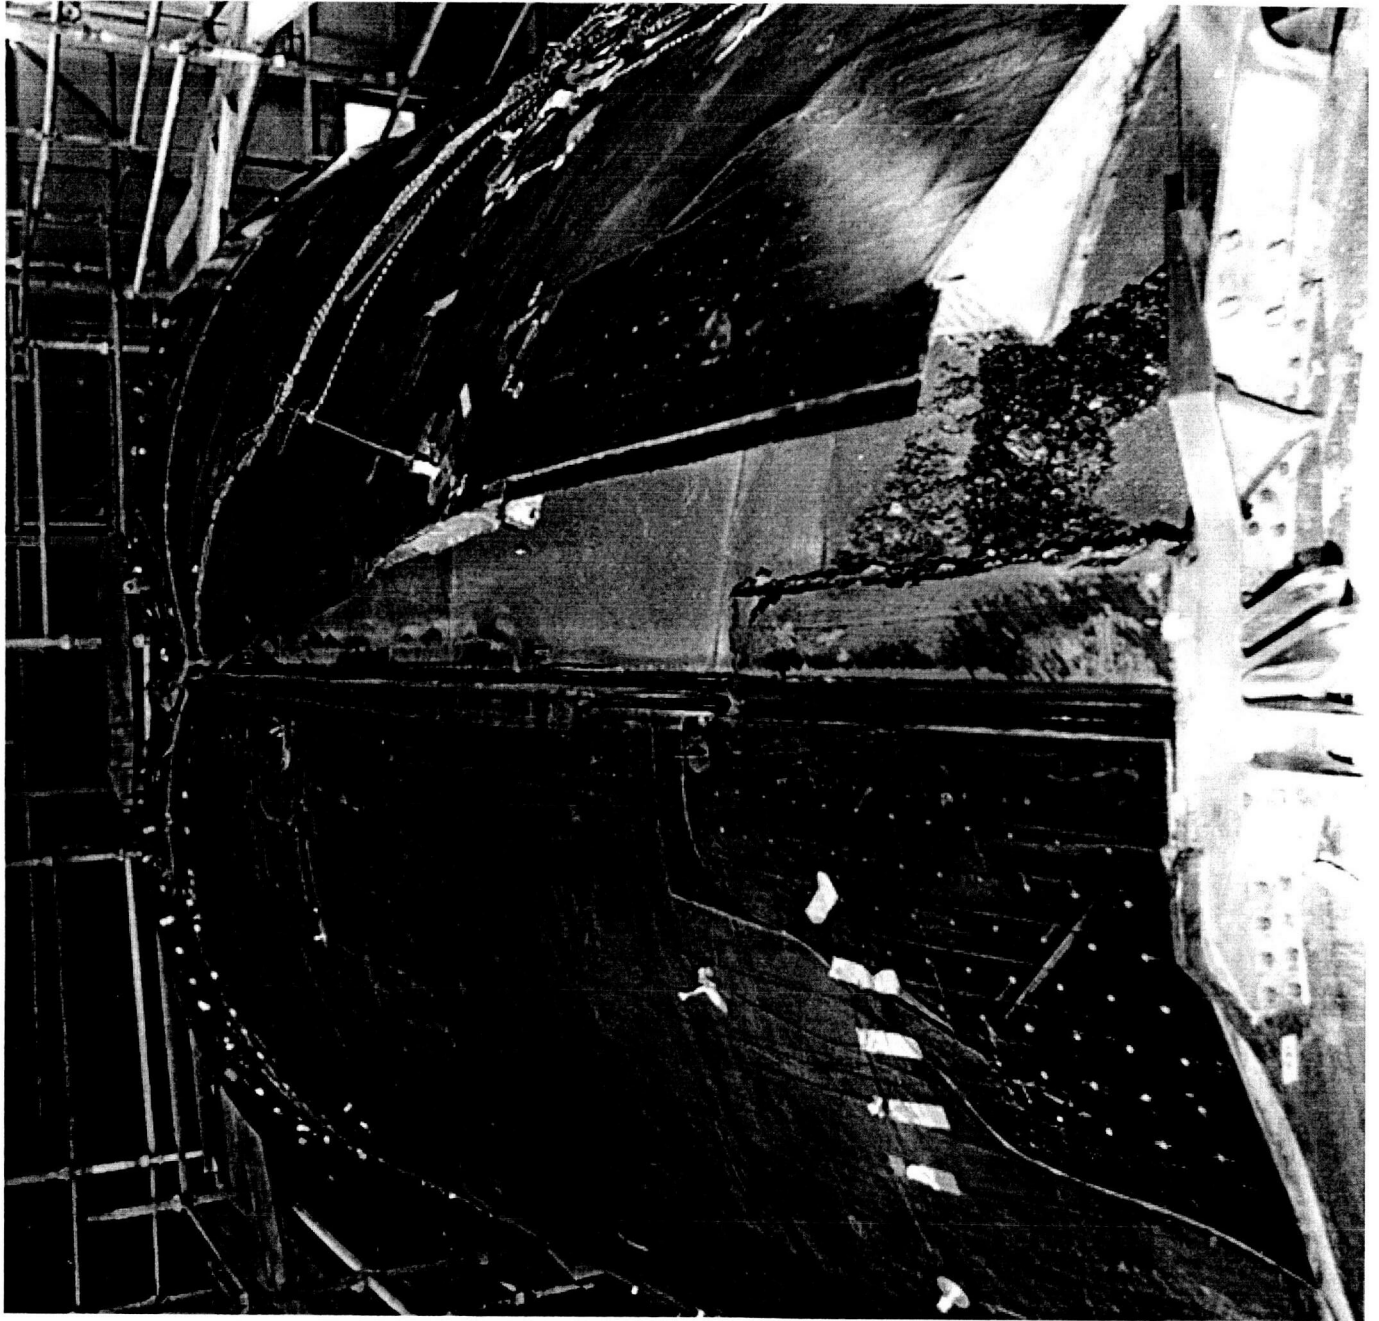
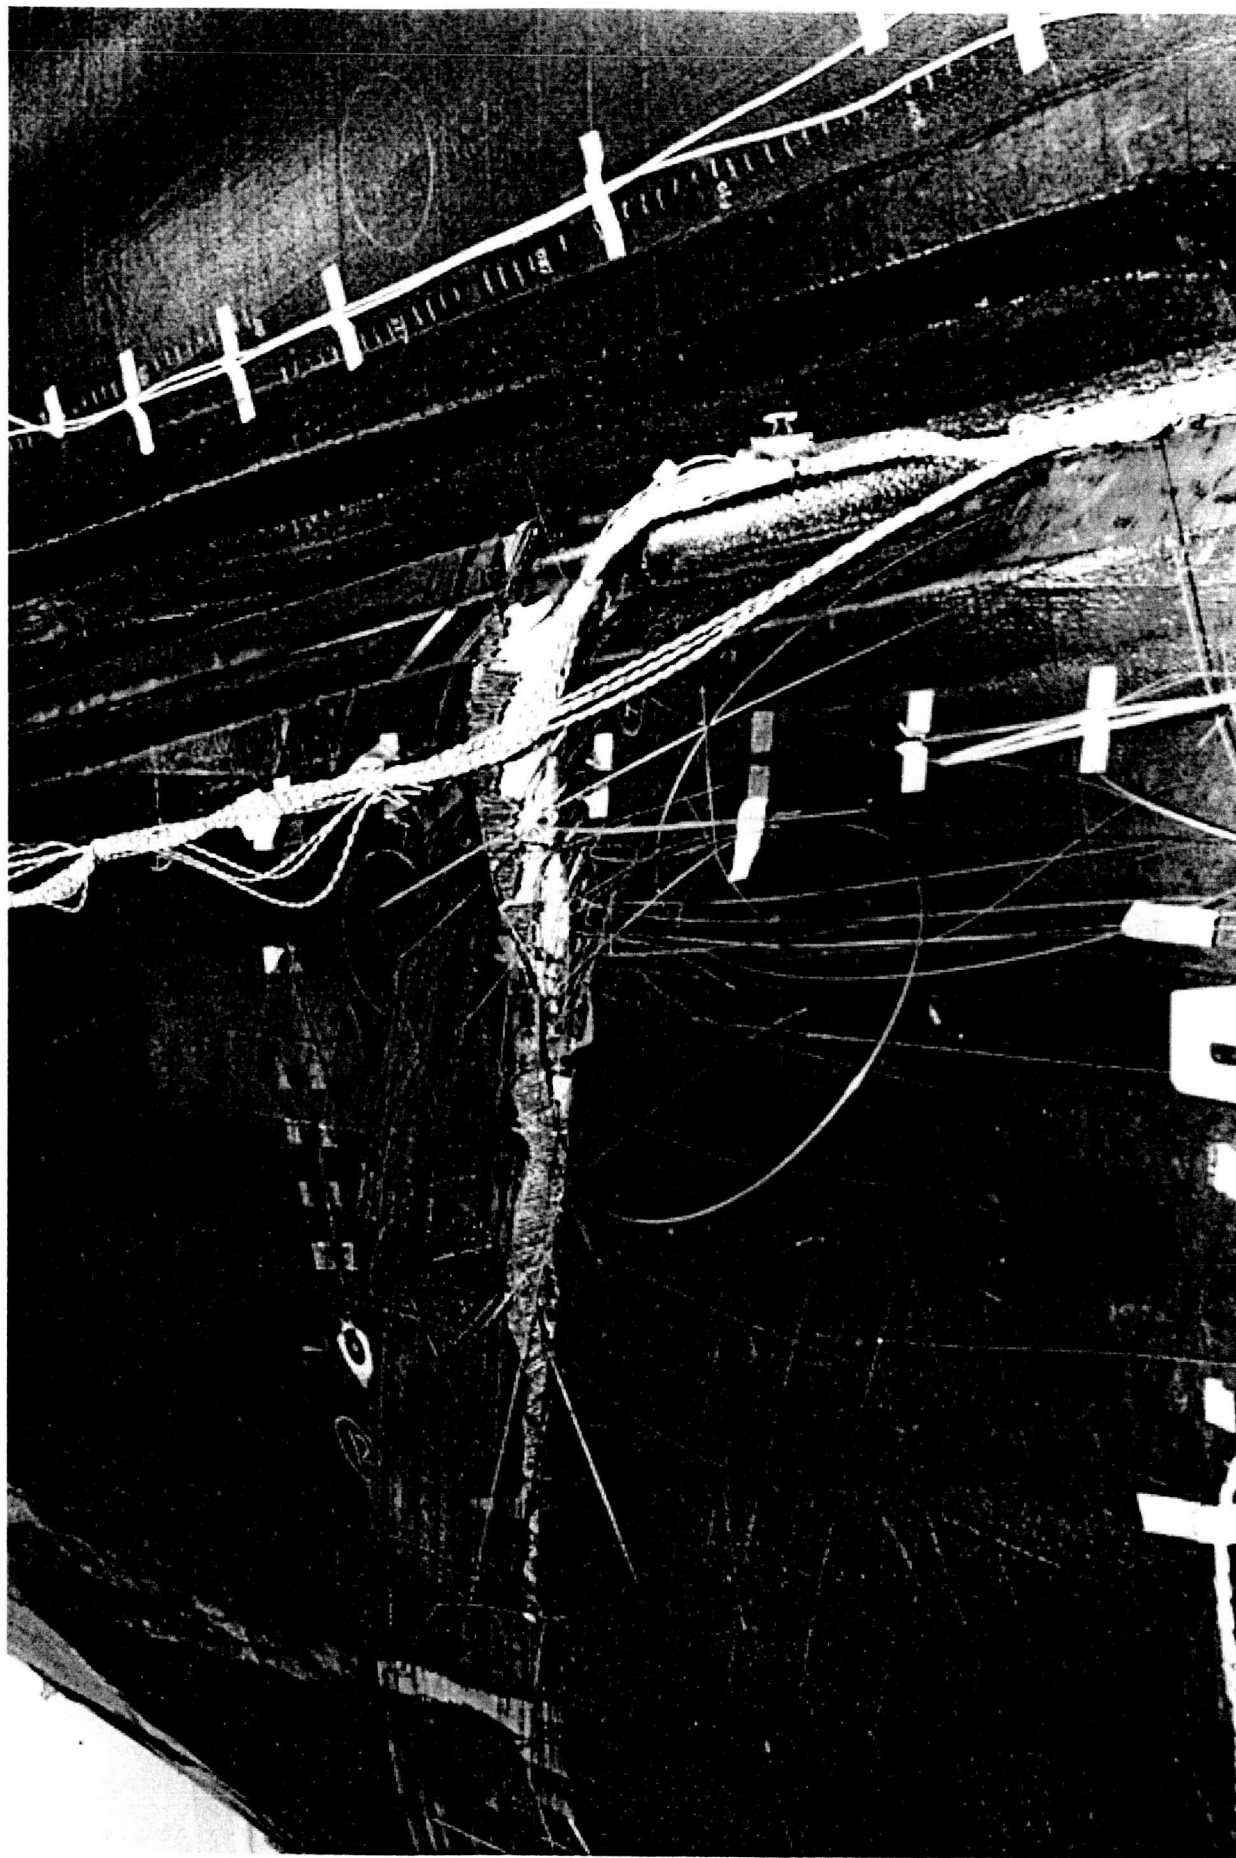
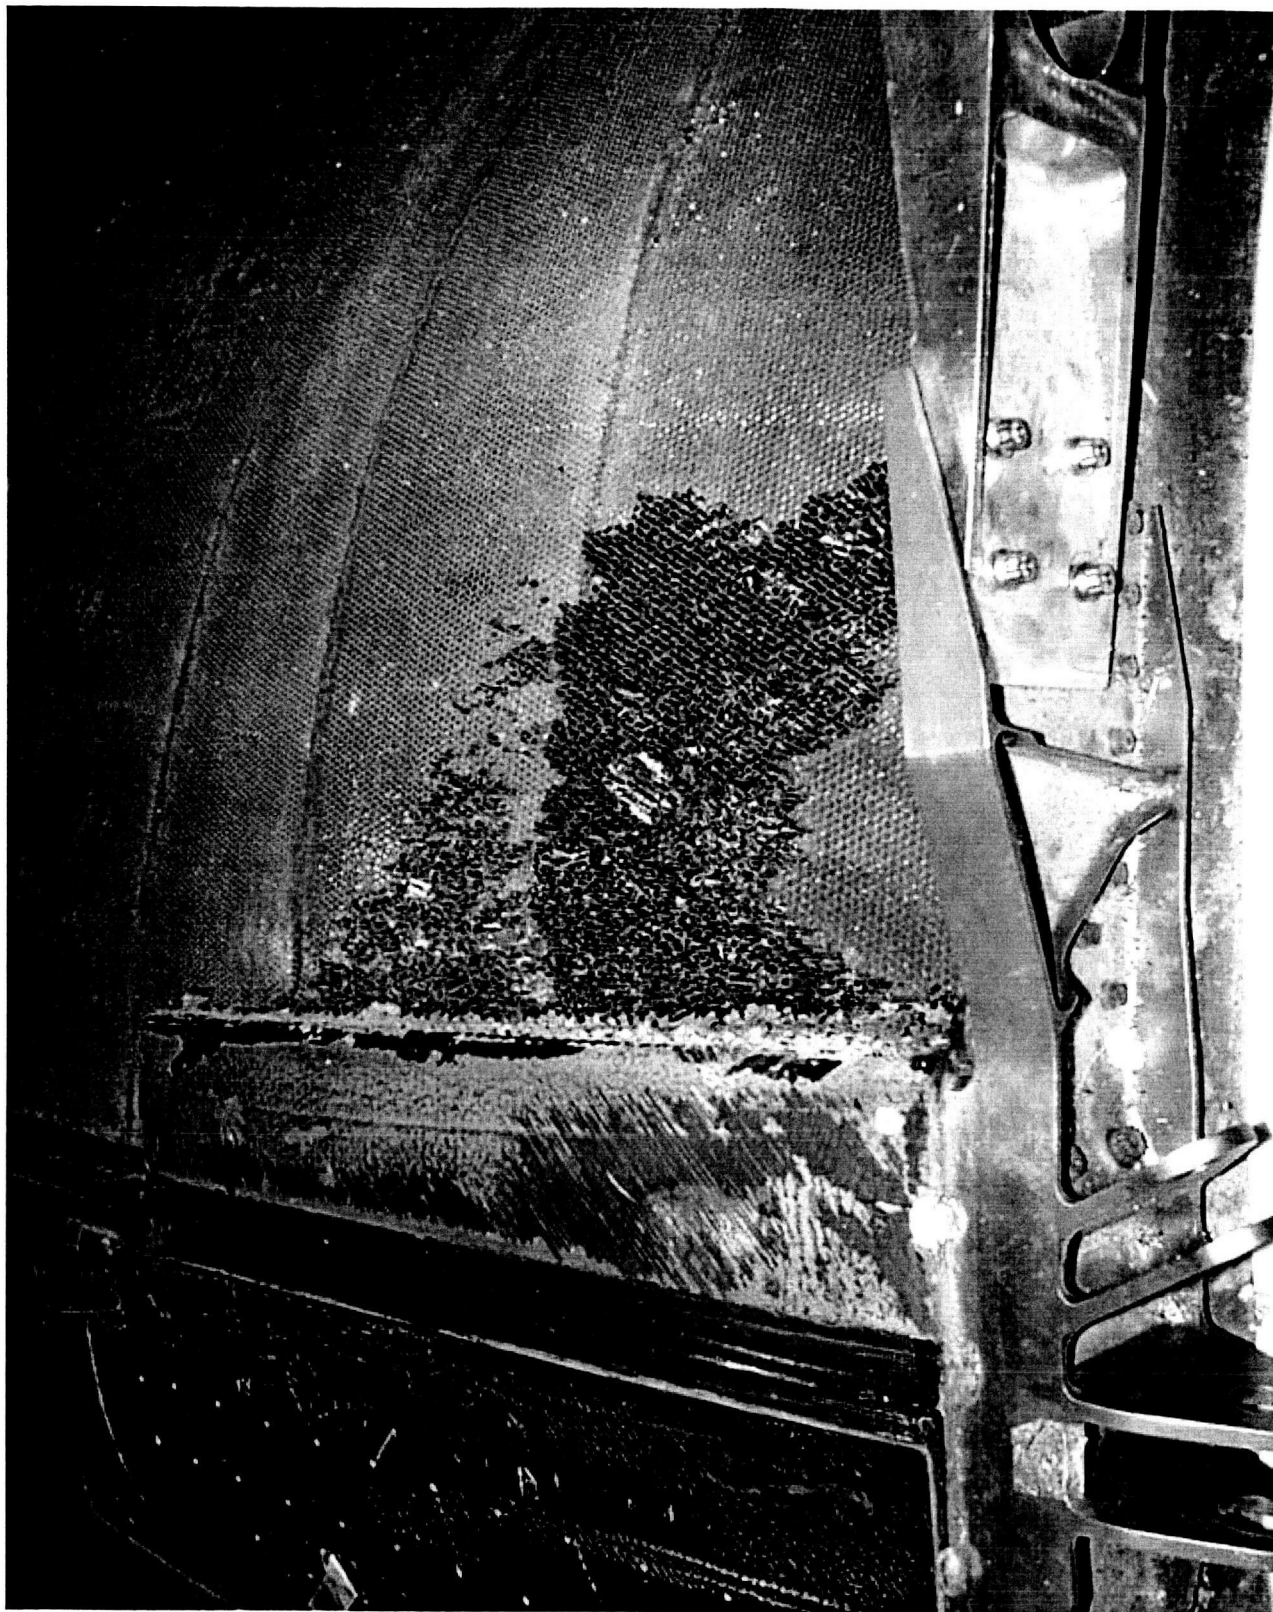
- **Peel Failure**
 - **Outer skin and core peeled away from inner skin**
- **Core Failure**
 - **Core is 'mangled'**
 - **Hydraulic fluid on test article**
 - **Foreign Object Debris (FOD)**
 - **Poor bondlines**
- **Pressure in core above ambient 13 hours after failure**

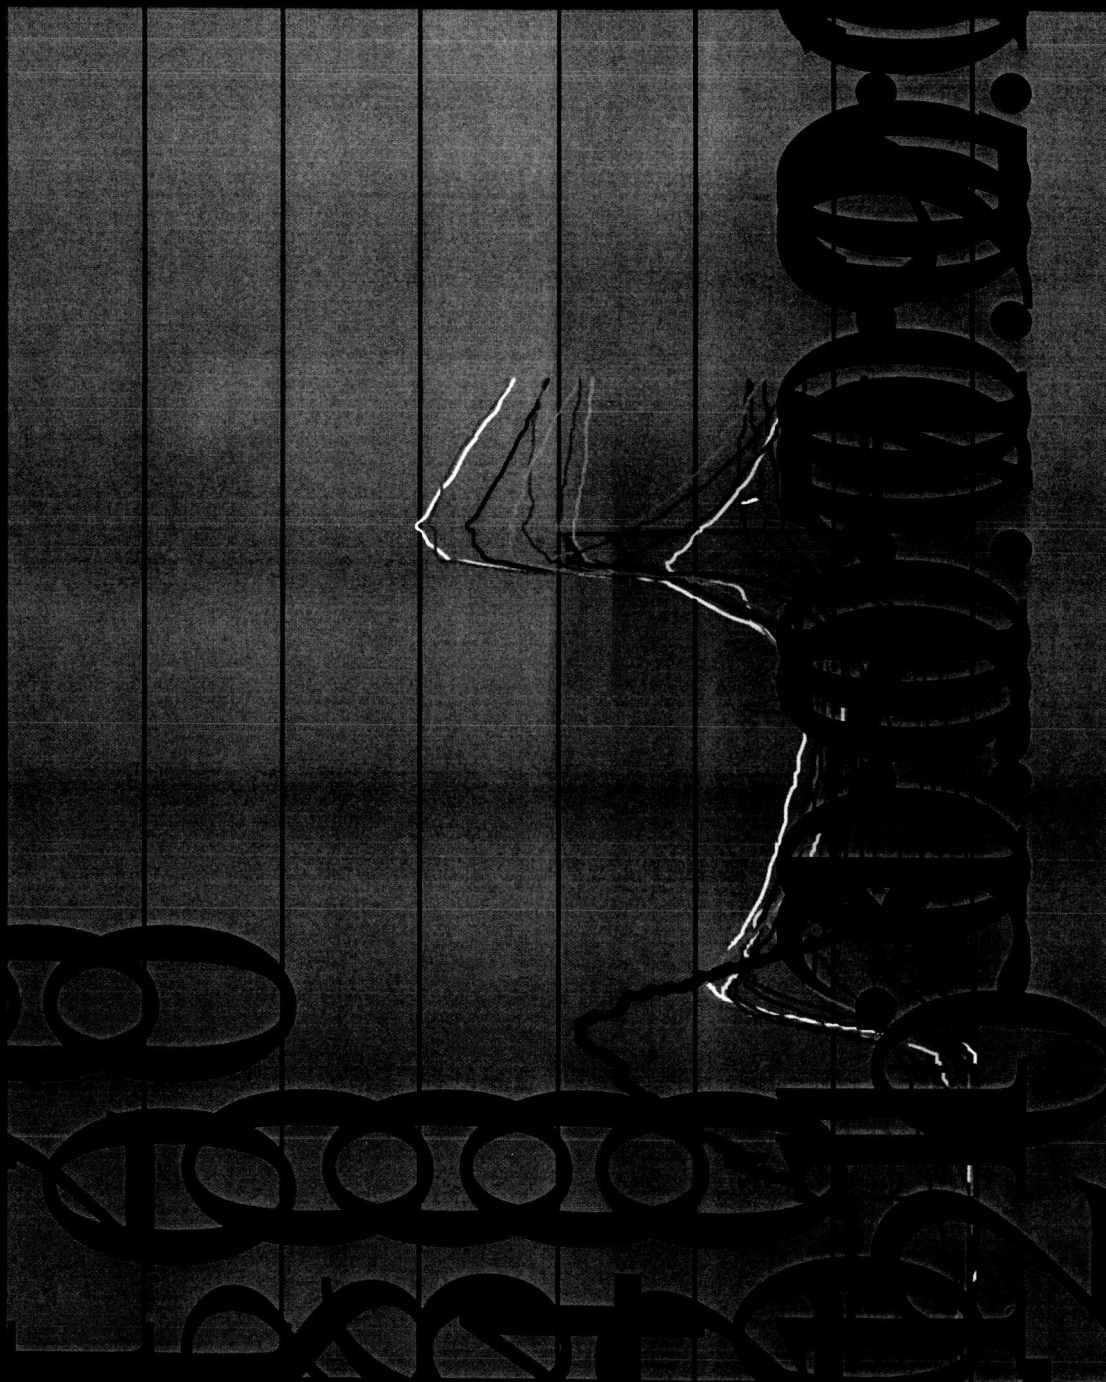
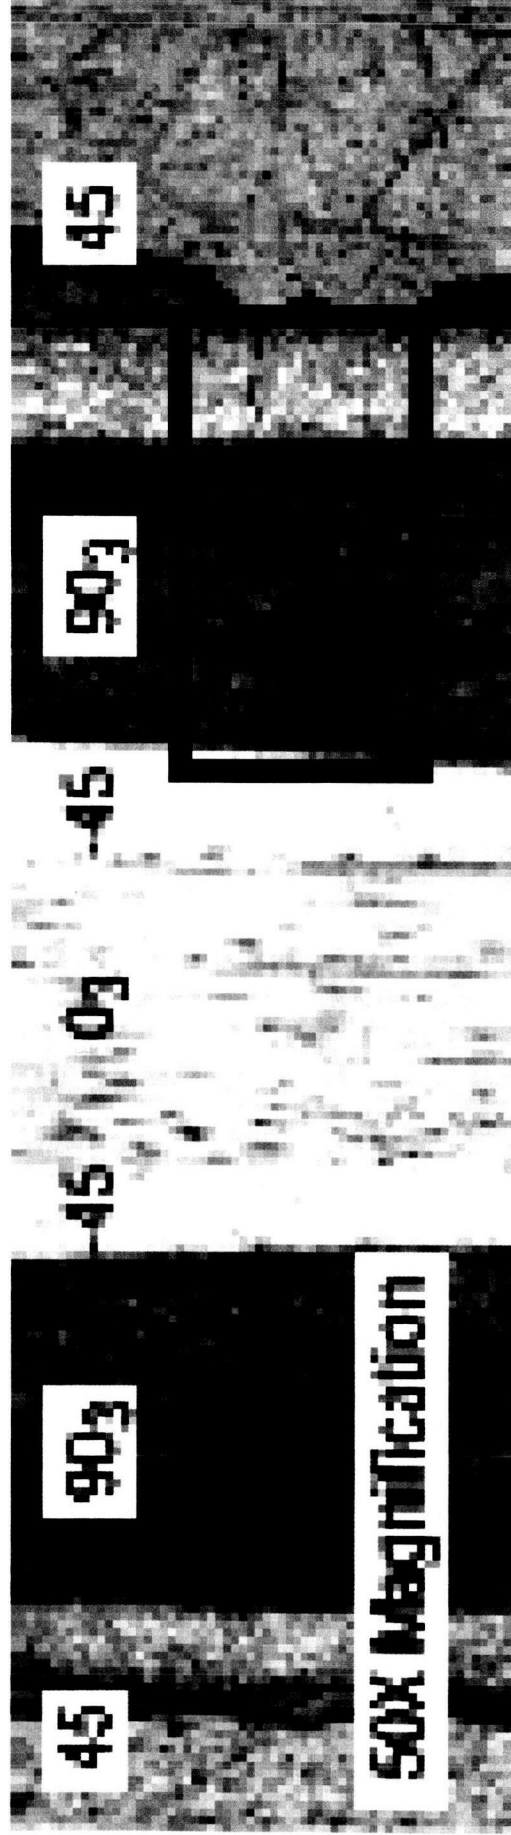
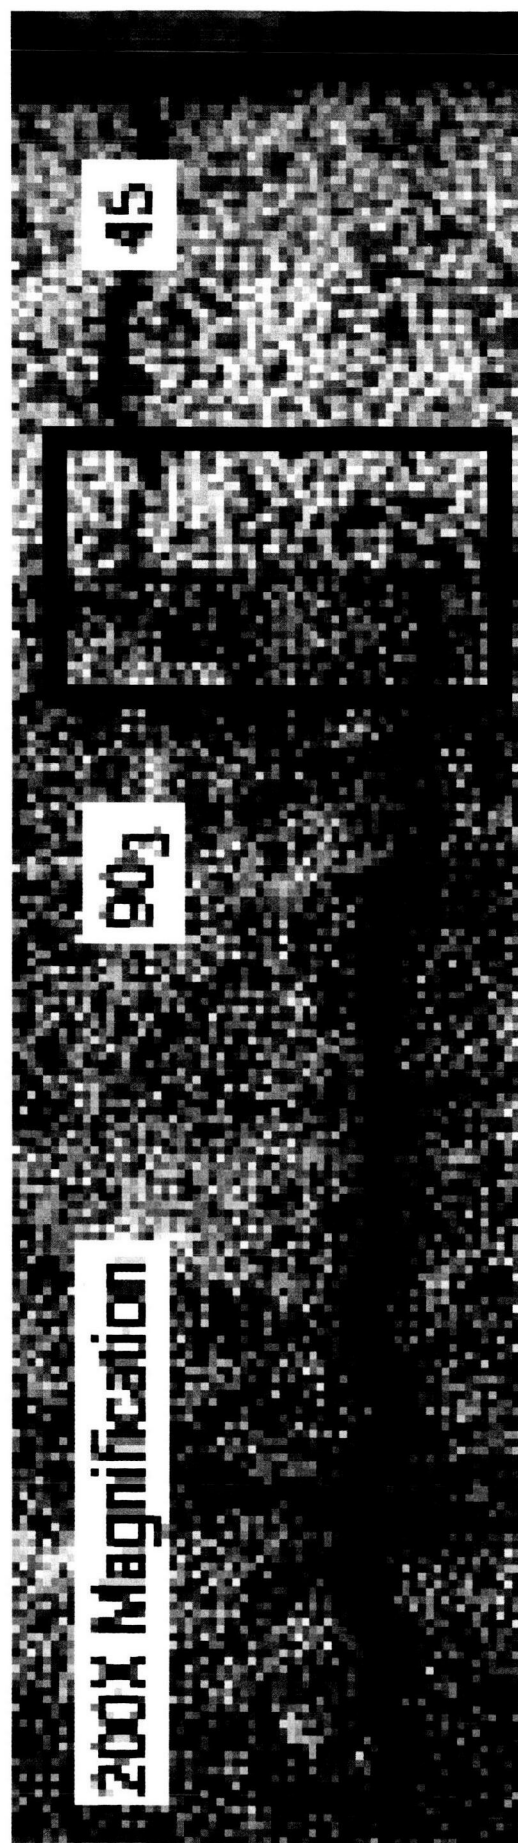
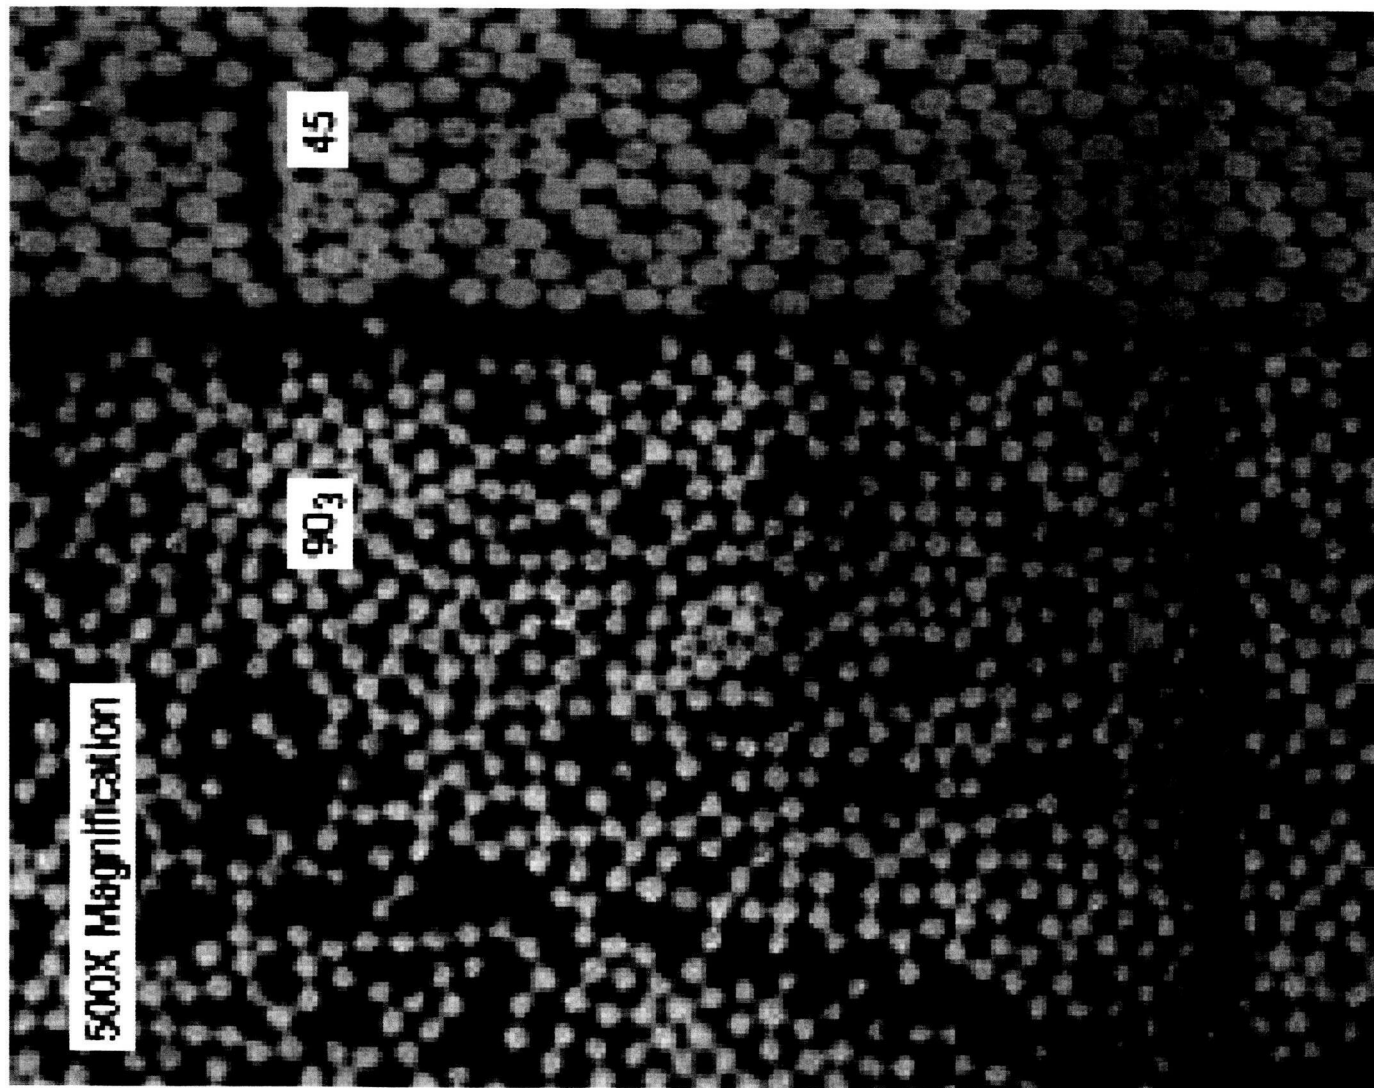
- Core pressures behaved unexpectedly
- Microcracking

- The inner skin microcracked and hydrogen infiltrated
- The cracks grew larger under pressure
- When pressure was removed cracks closed slightly
- When tank was drained and warmed, cracks closed and blocked leak path
- FOD and debond areas provided an opportunity for a leak path
- There is still hydrogen in the other 3 lobes today
